## APPEAL OF REMOVAL PERMIT DENIAL

I respectfully appeal the denial of my requests for removal permits for two trees: a 30" hazardous pine tree and an approximately 18" hazardous dogwood tree. In the alternative, the fines assessed should be reduced to \$200 based on my perceived necessity to remove these trees. The following is a Declaration concerning what I allege to be the facts of this appeal. I am attaching exhibits to declarations to support this appeal.

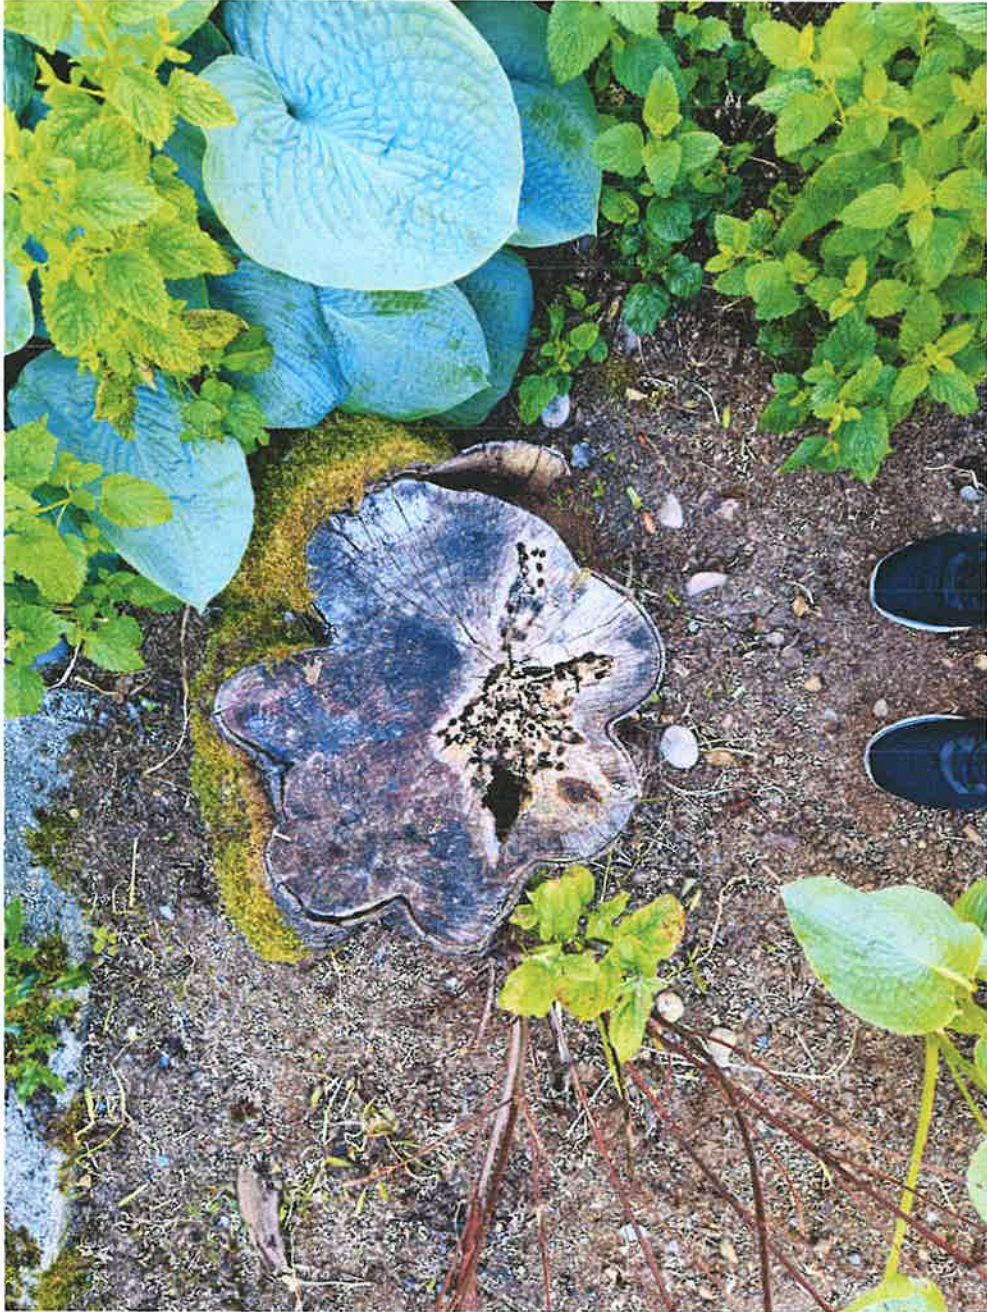
## EXHIBIT D

I, Cornel Termure, am over the age of 18 years old and am competent to give evidence concerning my appeal of the City's denial of my previous requests for a tree removal permit for a 30" pine tree and an approximately 18" dogwood tree located at 13506 132<sup>nd</sup> Ave NE in Kirkland, Washington that was removed because of its hazardous condition (see tree positions on Exhibit "D" prior to removal).

The City also denied my permit to remove the dogwood despite objective proof that it had suffered butt and heart rot. It concluded "trees often exist with heartwood decay and continue to live as healthy trees" (Exhibit "D").
